FEDERAL REGISTER

Washington, Tuesday, December 4, 1956

Section 1.24 of the Civil Air Regulations provides, "Where the Administrator finds, as a result of service experience, that an unsafe condition exists with respect to a design feature, part, or characteristic of any product, and that such a condition is likely to exist or develop in other products of the same type, he shall provide notice thereof for all operators of products of that type." Implementation of the provisions of this section will be accomplished by the Administrator through the issuance of Airworthiness Directives, and publication thereof in the FEDERAL REGISTER as Part 507 of the regulations of the Administrator.

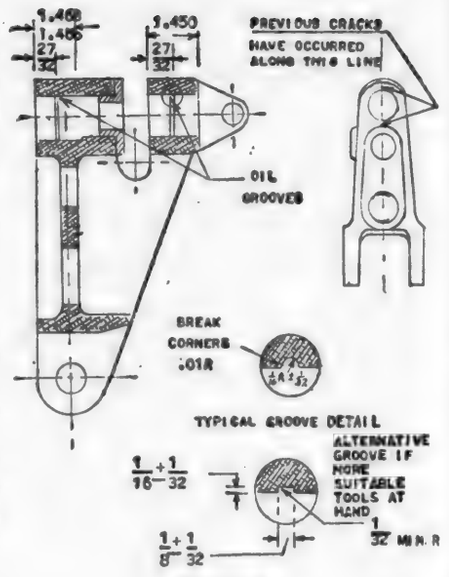
FIGURE 3.

2. Visually inspect main rotor links, part No. VS 36181 by one of the following methods for cracks around link pin hole and longitudinally along what was the flash line in original forging. (See Figure 3.) If cracks are present, links should be scrapped.

3. Machine oil grooves. (See Figure 3.)

(b) If bearings removed are part No. AT–16–OH and retainers washers are damaged or show evidence of foreign matter, they are to be replaced.

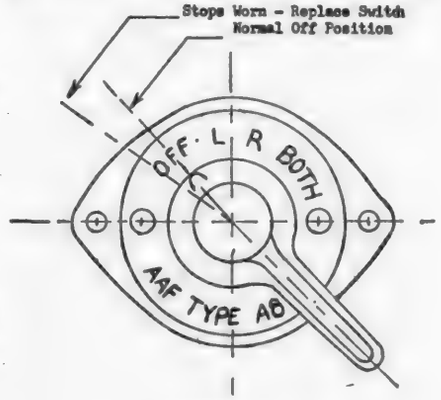
FIGURE 12.

position. The pointer projecting from the lever points to the middle "F" in the word "OFF." When the lever can be turned to a point beyond the centerline of the "O" in the word "OFF," the rotation stops have become worn and the switch should be replaced.

1. Inspection should consist of the following: Check switch lever for overtravel past the "off" position. The sketch below shows the location of the switch lever in the "off"

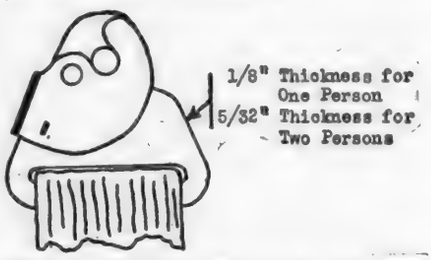
WARREN MCARTHUR FITTING No. 275–AS26
FIGURE 13

Care should be taken not to confuse these fittings with another Warren McArthur fitting P/N 13971 (also known as P/N 314–AS12) which is identical in appearance except that the fitting plate thickness is 5/32 inch.

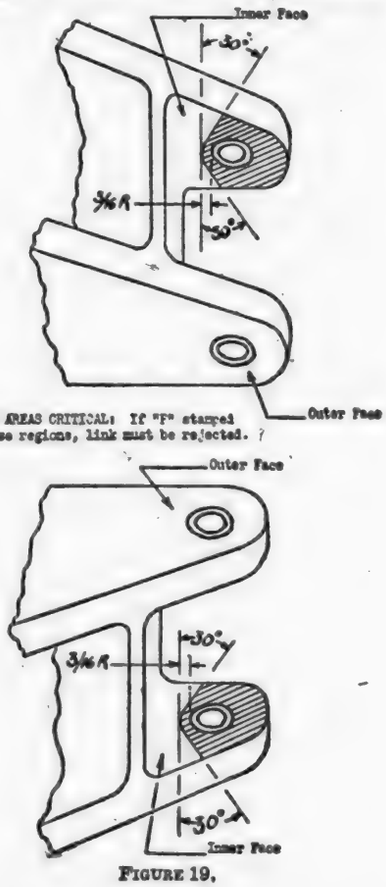
FIGURE 19.

(P/N S510348) received from the manufacturer between June 1 and September 6 inclusive for location of the identification stamp "F". Links with the "F" metal-stamped in the critical area on the inner faces of the ears should be retired from service. Those with the "F" stamped on the outer faces or on non-critical areas of the inner faces of the ears should be polished locally with emery and crocus cloth to remove the "F" and the links may be returned to service. (Sikorsky Information Circular Number 175, dated September 7, 1951, covers this same subject.)

1. Compliance required prior to next flight. Inspect all main rotor Link Assemblies

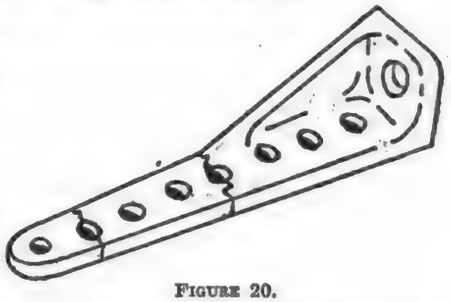
FIGURE 20.

(2) A magnet may be used to determine if the fitting is a steel casting.

(3) Fittings that have been made from aluminum alloy forgings can be readily differentiated from those made from bronze castings by visual inspection.

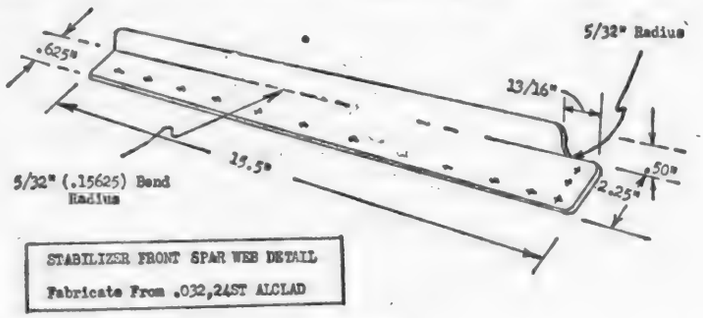
FIGURE 27.

Inspect as soon as practical, but not later than February 1, 1953, and at 100 hour intervals thereafter the area in the vicinity of the stabilizer fuselage attachment for cracks. Particular attention should be given to the stabilizer spar web (gusset) immediately outboard of the root rib and the fuselage attaching fitting. If cracks are found in the fuselage fitting, P/N 143-31004-13, the entire part should be replaced. Cracks in the root rib may be repaired in accordance with CAM # 18. Cracks in the spar web (gusset) require the replacement of the gusset with a new part made in accordance with the following sketch.

Periodic inspections of stabilizer spar web only may be discontinued after installation of new gussets. (Ryan Navion Field Service Bulletin # 17 dated September 26, 1952, covers this same subject.)

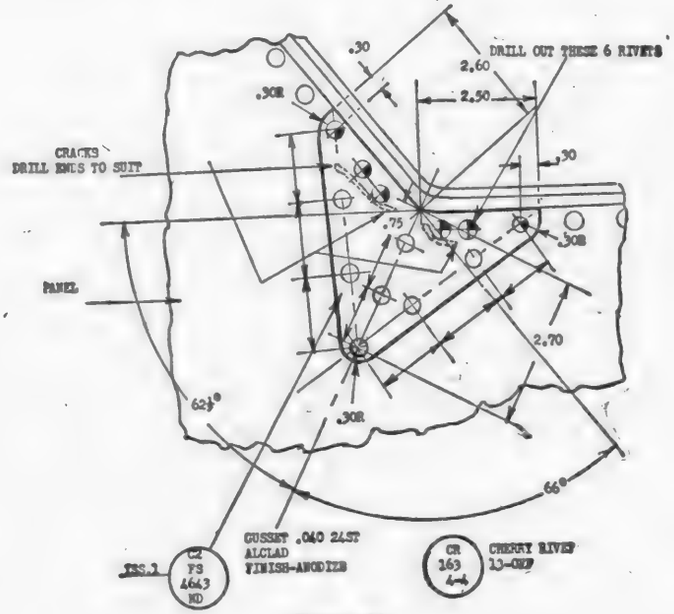
FIGURE 30.

VIEW ON FUSELAGE SIDE PANEL AT FRONT DOOR STEP SHOWING TYPICAL METHOD OF REPAIRING SKIN CRACKS.

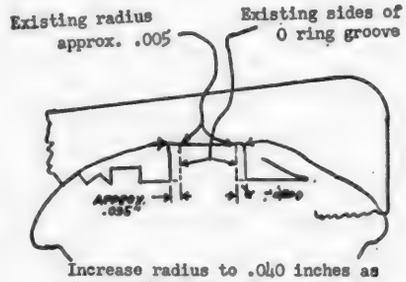
FIGURE 32.

Remove the landing gear retraction cylinder head and inspect the upper and lower radii of the O ring groove for cracks by means of a dye penetrant. If cracks are found the part should be replaced. In the event no cracks are present the upper and lower radii of the O ring groove should be increased to 0.040 inch as shown in the sketch below and again inspected by means of a dye penetrant. If no cracks are found after this inspection, the part may be returned to service; however, if cracks are evident, the part should be replaced.

NOTE: Smooth machine finish (RMS–32 or better) with no tool marks or discontinuities. No change in size of O ring necessary.

Increase radius to .040 inches as shown. New radius tangent to original depth of groove but requires increasing width of groove approximately .035 inches per side.

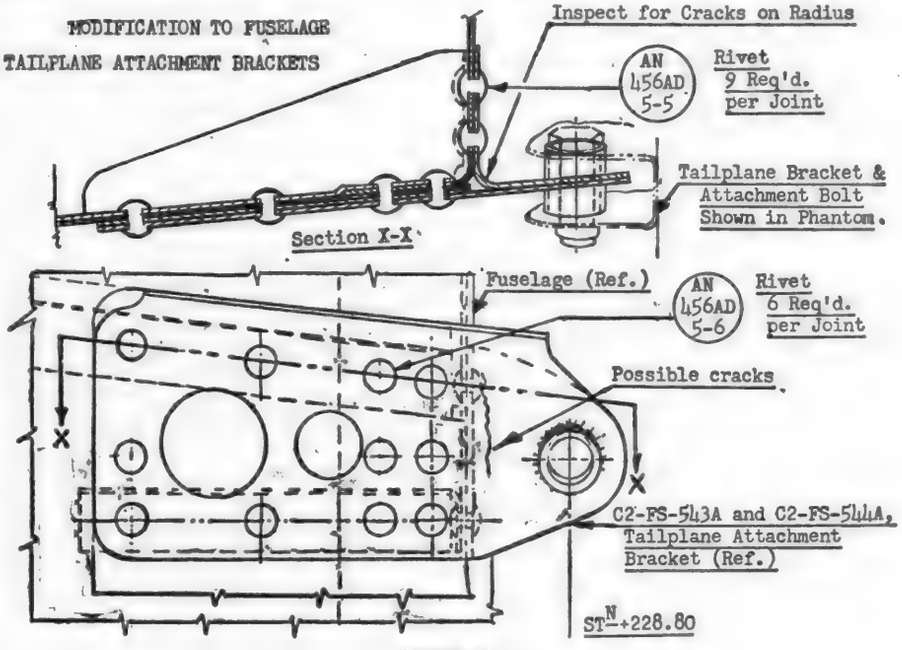
FIGURE 33.

Inspect subject brackets for cracks and distorted rivets at the location indicated in figure 33 and replace the tailplane front attachment ¼-inch diameter bolts Part No. NAS 54AN12 at intervals not exceeding 1,000 flying hours. If brackets are defective, replace with new parts. If existing ⅛-inch diameter rivets are distorted, replace with 5/32-inch diameter rivets as outline in figure 33.

If the aircraft has exceeded 1,000 flying hours, this inspection should be performed at some convenient opportunity not exceeding 200 hours subsequent to the date of this directive.
